# Manhole Inspection Summary

Manhole # S19M\_\_039MH

Insp Date: **3/25/08 8:47 AM**

**Location** Address: **441 smallwood-alley-pulaski**

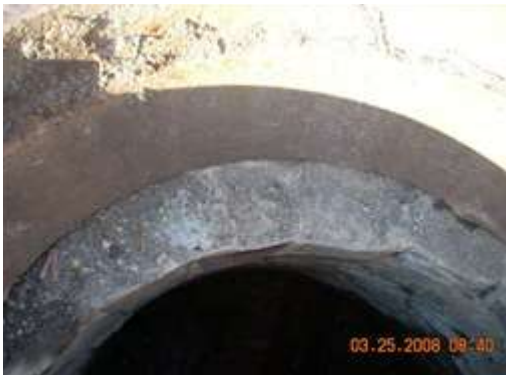
Defect 1

**Frame** Offset: **5** (in.) Condition: ☒ Sound ☐ Cracked ☐ Leaks

frame offset

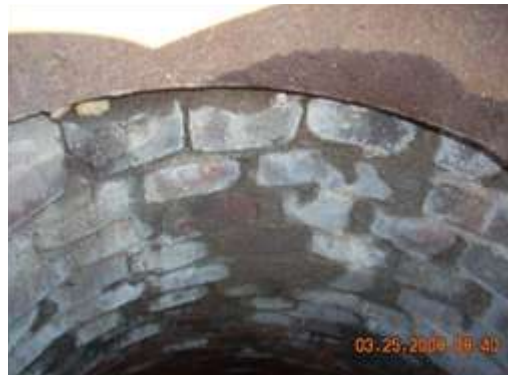
Defect 2

Infiltration: ☐ None ☐ Joint ☐ Cracks ☐ Mortar ☐ Roots ☒ Wall

infiltration of the corbel wall

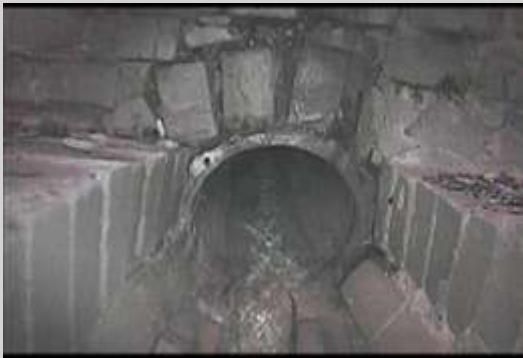
12 O'Clock Outflow

8 in. Circular Gravity Sewer  
Pipe Out @ 12 O'Clock

Pipe Height: **8.4** (in.) Rod and Bar (Angled)  
Pipe Material: **Clay** ☐ Pipe Lined  
Invert Depth: **7.10** (ft.) Flow Characteristics: **Slow**  
Deposits: ☒ None ☐ Mud ☐ Sludge ☐ Debris ☐ Grease  
Silt Depth: **0** (in.) Deposits Extent:  
Infiltration: **None** Pipe Seal Cond: **Sound**

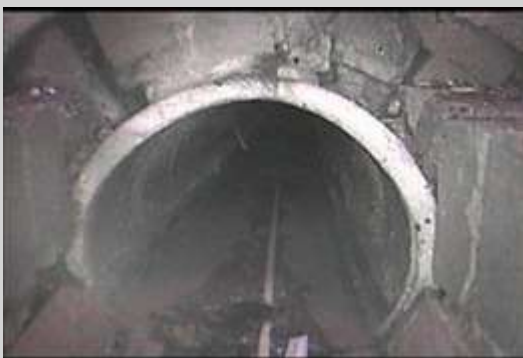
4 O'Clock Inflow

8 in. Circular Gravity Sewer  
Pipe In @ 4 O'Clock

Pipe Height: **8.4** (in.) Rod and Bar (Angled)  
Pipe Material: **Clay** ☐ Pipe Lined  
Invert Depth: **7.05** (ft.) Flow Characteristics: **Slow**  
Deposits: ☒ None ☐ Mud ☐ Sludge ☐ Debris ☐ Grease  
Silt Depth: **0** (in.) Deposits Extent:  
Infiltration: **None** Pipe Seal Cond: **Sound**
